WVT-TR-77019

ULTRASONIC AND ACOUSTIC HOLOGRAPHIC TECHNIQUES FOR
INSPECTION OF COMPOSITE GUN TUBES AND
OTHER WEAPON COMPONENTS

BENET WEAPONS LABORATORY
WATERVLIET ARSENAL
WATERVLIET, N.Y. 12189

TECHNICAL REPORT

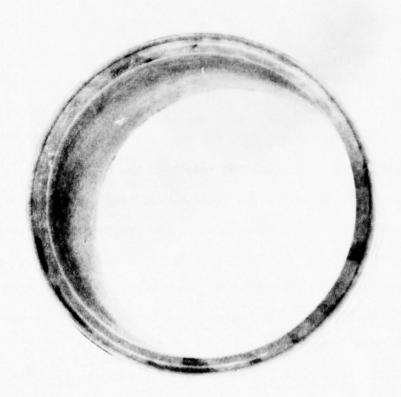
Figure 10. 81mm RCLR fiber glass epoxy chamber.

Figure 10 shows the cylindrical geometry of the two fiber glass test samples taken out of the 81MM recoilless rifle*. (Reference: Watervliet Arsenal Technical Report WVT-TR-74014: "Development of: Design Analyses, Manufacturing, and Testing of the 81MM XM73 Fiber Glass-Epoxy Recoilless Rifle", June 1974.) A pulse-echo method for disbond detection from the outer perifery of the fiber glass cylinders was employed. A metal liner was placed concentrically within each fiber glass cylinder. The assembly was mounted on a rotating fixture and immersed in the water below the scanner. Figure 11 shows the above setup. The signal reflected from the inner cylinder is detected by the gate. The absence of the gated signal would indicate the presence of a flaw.

Chamber depicted in Figure 10 is an adhesively bonded item which has been successfully test fired. In addition to what is shown in above sketch, the tube section has twelve (12) equally spaced bleeder slots going from the well to the Y location. These slots, which are $^{\circ}$ 0.030" wide and 0.005" deep, allow excess adhesive to escape to the outside of the joint. 5
